A.	GENERAL INFORMATION	
1.	Street Address of the School: Ave. Munos Bivera, Esq. Gll Y Toste Hate	Dey !
	city: San Juan state: Puer to Bico zip:	
2	( , - 1 1 1 0

2.	, ,	
3.	Date of inspection: 0//15/20 to 0//16/20	
4.	Inspector's Name: José A. Fernandez Polo, PE, José C. Ortiz,	EI
В.	BUILDING SITE INSPECTION	
5.	Utility Service Safety:	
detecte	RTANT-Immediately following an earthquake, check the entire property, especially near appliances, for the smell of gas. If gas led, turn off the gas at the meter where it enters the house. Locate and repair leaks before turning gas back on. If the gas odor he gas has been shut off, vacate the building and contact the gas utility company immediately.	odor is persists
	RTANT-Before entering a damaged, vacant building verify that gas is off. Check the gas meter for damage and position of main either a manual valve or a seismically-activated gas shut-off valve. Do not enter the building if gas odor is detected.	gas

G.	RECOMENDACIÓN
	Hora de Entrada 8:00 am M Hora de Salida de 5:00 pm lu Inspección:  Edificio: Centro Judicial San Juan Código:
	Edificio: Centro Judicial San Juan Código:
	Municipio: San Juan Fecha de Inspección: 01/15/20
	Abrir (

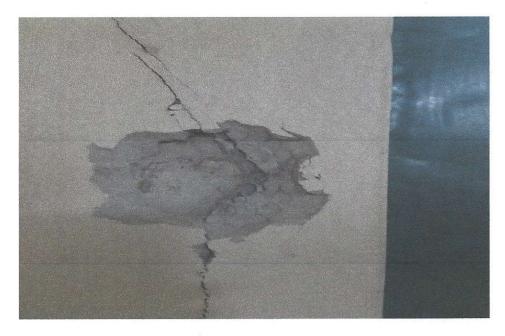
- 4. En varios lugares del edificio, se presentan algunas grietas menores en el empañetado. Las mismas no afectan la integridad de la estructura, no obstante, recomendamos se corrijan. Se realizaron varias exploratorias y se descartó que las mismas fuesen estructurales.

- 5. En el área de la Secretaria Regional en el segundo nivel del Anexo sur, se presenta una grieta en la columna, la misma responde a la unión de la columna y un "chase" en bloques que se creó para la tubería de escape del generador de emergencia. Esto no representa ningún daño estructural.

Exploratoria en Columna. (Grieta en el Empañetado no daño estructural.

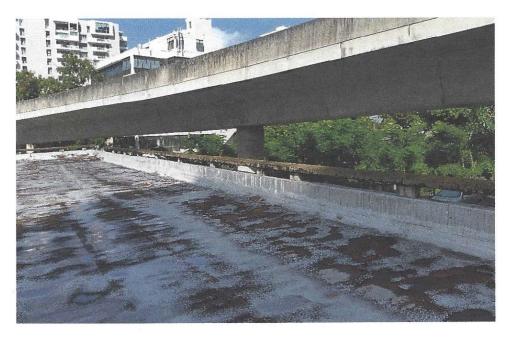
- 3. En los techos de los anexos norte y sur, presentan unos elementos (barandas) prefabricadas en la parte superior de los parapetos del perímetro de las estructuras. Recomendamos que estos elementos sean sustituidos ya que en un movimiento abrupto de la estructura podrían desprenderse y golpear a las personas que estén saliendo de la estructura. Se deben tomar las medidas de seguridad necesarias para proteger a los peatones en lo que corrige la situación.

Tope en los parapetos anexos norte y sur. Recomendamos reemplazar.

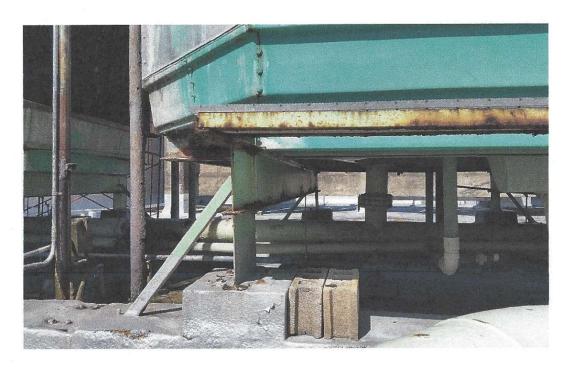
- 6. En la azotea del edificio, se ubican tres (3) torres de enfriamiento. Las estructuras en acero de las mismas se encuentran corroídas. Aunque esta situación no afecta la operación y apertura del edificio, recomendamos se evalúe esta condición con un lng. Estructural y reemplazar estos elementos.

Base de las Torres de Enfriamiento.

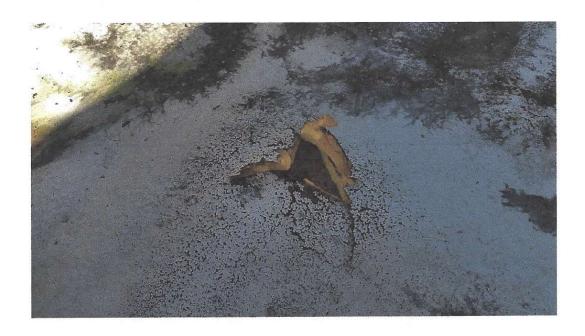
- 7. Se puede observar que el sistema de impermeabilización del edificio principal está en mal estado. En varios lugares se puede notar acumulación de agua y desprendimiento del mismo. Recomendamos su reparación, esto para evitar el deterioro del edificio, en especial las áreas con filtraciones en el nivel once (11).

Sistema de Impermeabilización Afectado.
